NASA Contractor Report 165928

AIRCRAFT SURFACE COATINGS

ENERGY EFFICIENT TRANSPORT PROGRAM

Contract NAS1-15325, Task 4.4

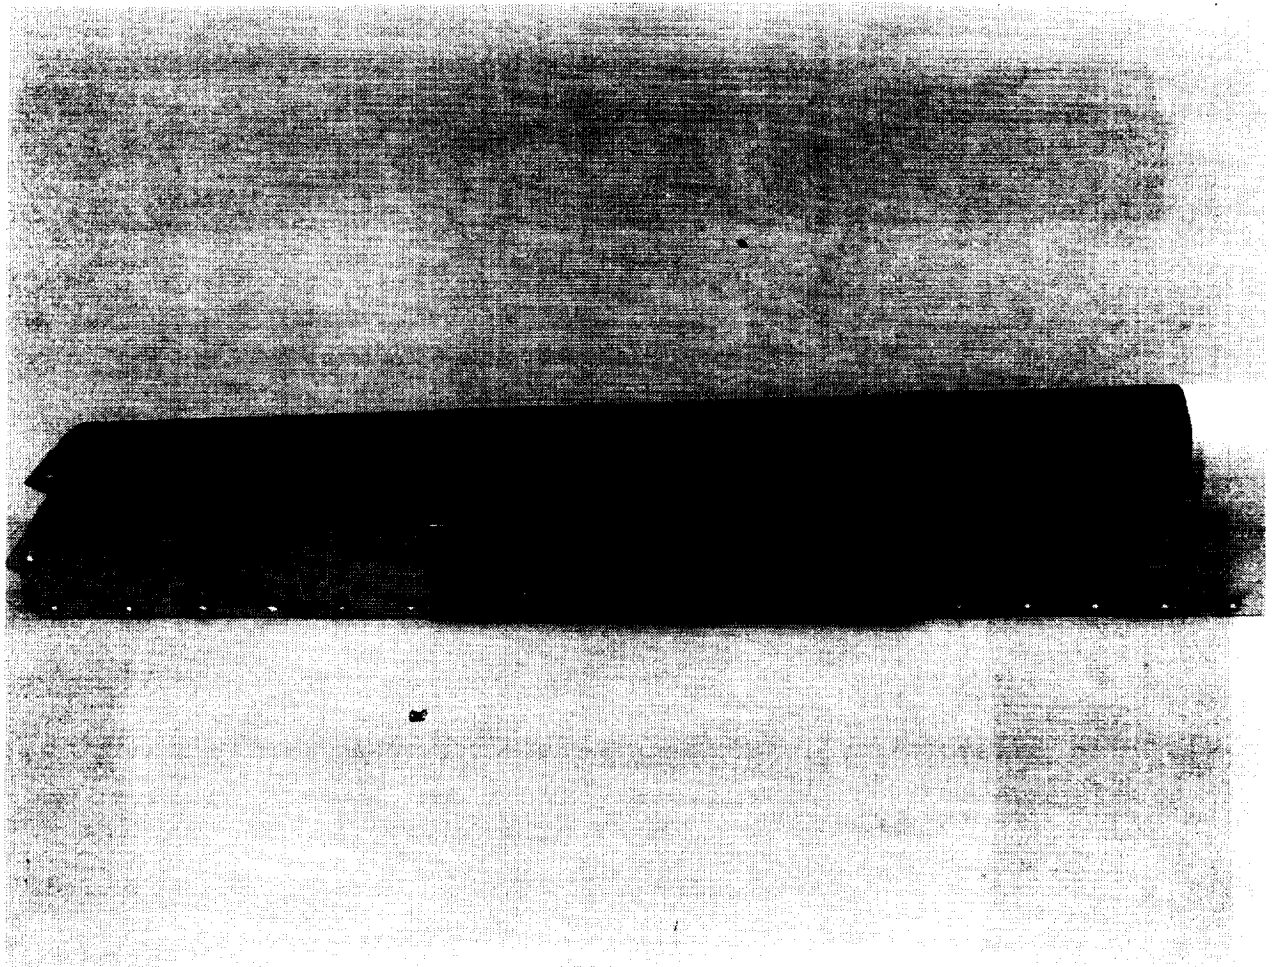
(b) Chemglaze Panel—Good Condition, Except Some Dulling

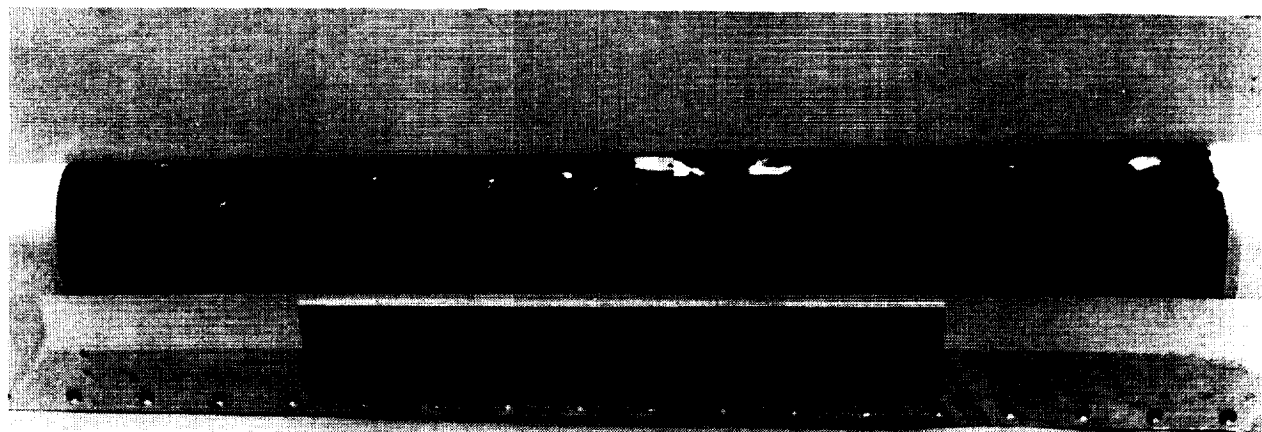
(c) Astrocoat Panel—Extensive Leading-Edge Damage

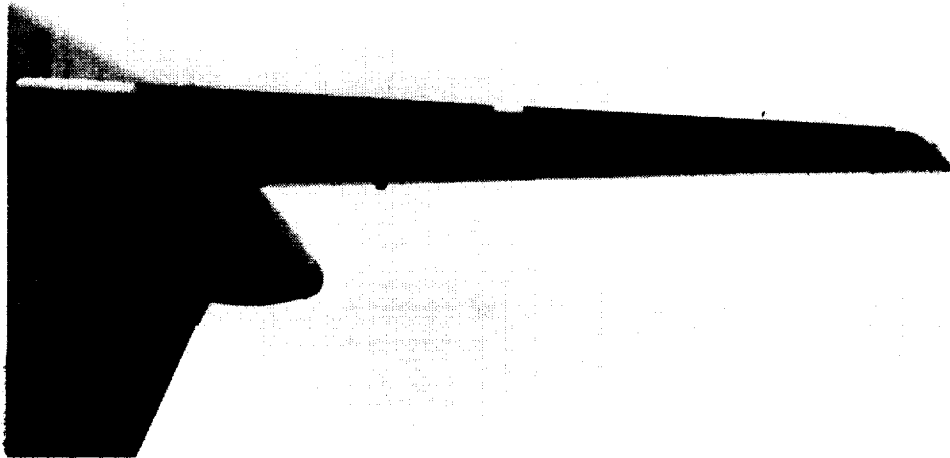
The right horizontal tail leading edge is shown at 6435 hours in Figure 35. The inboard panel, coated with Chemglaze, had erosion at the inboard end that grew to about 5 cm (2 in) by the end of the evaluation. Also, there were two peeled spots on the leading edge about 2.54 cm (1 in) in diameter. The outboard panel began losing CAAPCO coating very early, and the coating had to be removed at about 500 hours.

(a) Chemglaze Coating in Good Condition; CAAPCO Spotted
